PROBLEM SOLVED™ PAPER

SOLUTION: Martin® BD Cleaner

INDUSTRY: Aggregate

LOCATION: Limestone Quarry
Georgia

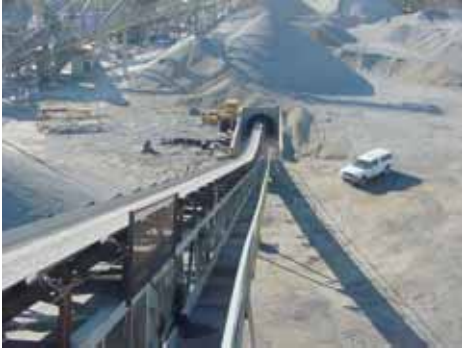
Conveyors at this Georgia quarry suffered from high amounts of carryback.

The quarry's belt conveyor system suffered from excessive carryback, creating clouds of dust and burying rolling components. Even a multiple cleaning system (with a primary cleaner and three secondary cleaners) had not successfully controlled the wet material that adhered to the belts.

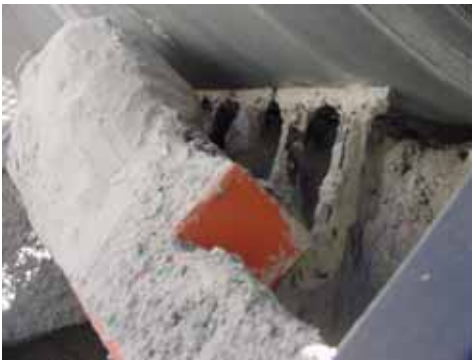
Installed at the five o'clock position near the bottom of the head pulley, Martin® BD Cleaner uses tungsten carbide edges to remove carryback.

To clean the sticky aggregate fines from the belt, the quarry installed a **Martin® BD Cleaner**. Installed at a five o'clock position, below the conventional primary cleaner position but still within the head chute, the **Martin® BD Cleaner** uses tungsten carbide blades to remove carryback and return it to the main material stream. Individually cushioned with Martin® Shock Absorber technology, the blades are held at a positive rake or peeling angle for effective cleaning at low pressure.
