PROBLEM SOLVED™ PAPER

SOLUTION: Martin® Belt Cleaners

INDUSTRY: Mining

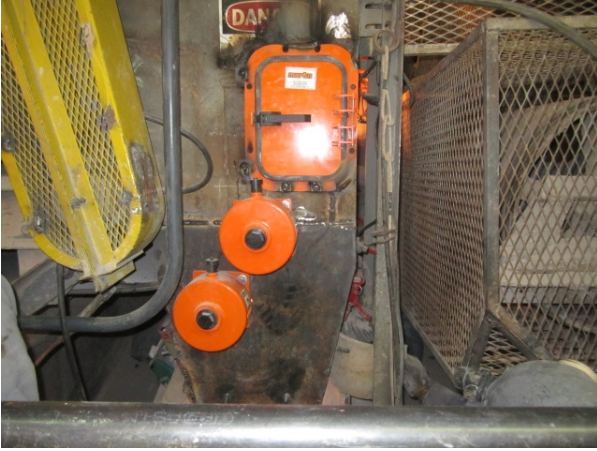
Spillage and carryback has always been an issue at the tail section of the conveyor. In order to correct the problem, Martin mounted two cleaners on the head pulley.

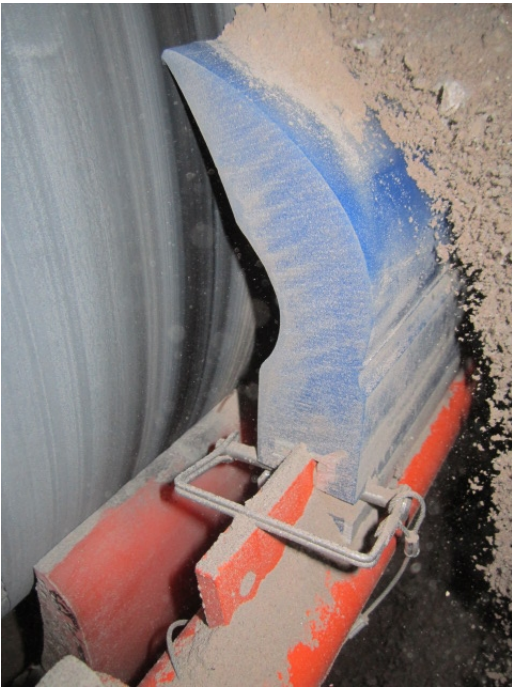
Martin® primary cleaner and a metal tipped secondary Cleaner

Martin installed two belt cleaners on the face of the head pulley. There wasn't enough room to modify the dribble chute to accommodate any secondary cleaners so two cleaners were squeezed into a very small area.

Upon successfully installing two belt cleaners on the face of the head pulley, within one week of operation, the belt was carryback free - for the first time EVER. The satisfactory results have led the plant to upgrade other belts to this dual-cleaner system and are considering transfer point upgrades and service arrangements with Martin Engineering.
