PROBLEM SOLVED™ PAPER

SOLUTION: Martin® ApronSeal Skirting

INDUSTRY: Mining

LOCATION: Arizona

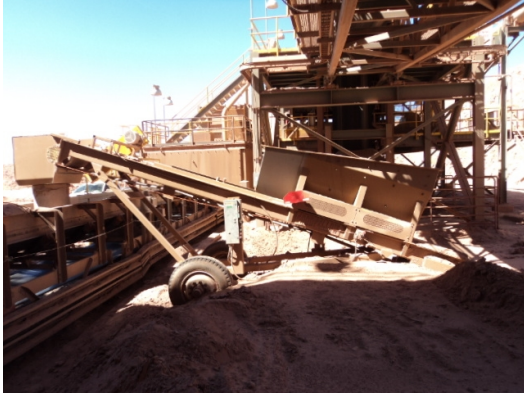
The plant was having a hard time keeping dust and fines from escaping the transfer point.

The existing skirting was not containing dust and spillage. This fugitive material led to the need for manual cleaning/shoveling of the walkway every day. The plant even bought a temporary conveyor to help alleviate this issue.

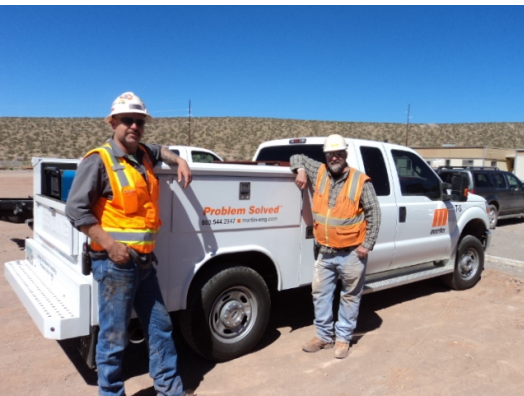
MartinPLUS® Service crew installed the Martin® ApronSeal Skirting.

Martin Engineering installed heavy duty Martin® ApronSeal Skirting on the conveyor that was constantly discharging spillage and dust. The Martin® ApronSeal Skirting formed an effective, low-maintenance, multiple-layer seal to keep fines on belt. The primary seal forms an inner barrier, keeping material inside the chute. The secondary seal captures fines and ribs carry those fines down the belt. Yielding long life and low maintenance, the low-pressure seal requires minimal adjustment. Minimal space is required to accommodate the Martin® ApronSeal Skirting and virtually any clamps can be used - making this an ideal replacement system.
