PROBLEM SOLVED™ PAPER

SOLUTION: Martin® Multi Port Air Cannon

INDUSTRY: Cement

LOCATION: Nuh Cement Plant Kocaeli Turkey

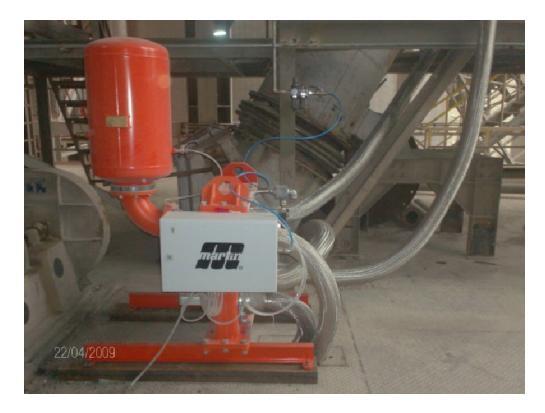
Keeping components centralized allows for easier and safer service.

To prevent blockages in the Cyclone discharge pipe, Martin Engineering determined suitable places for air nozzles, and installed two Martin® Multi Port Air Cannons. Martin® Multi Port Air Cannon technology provides easier service and maintenance as the components are centralized, minimizing exposure to heat and dust for personnel and moving parts. Martin® Multi Port Air Cannons use a single air reservoir with a control unit to replace up to eight traditional, tank-and-valve air cannons, improving process efficiency. Eliminating the need to hang heavy air tanks on vessels, installation is simple. The system is ideal for standard and severe-duty applications (high temperature/dust/stress).

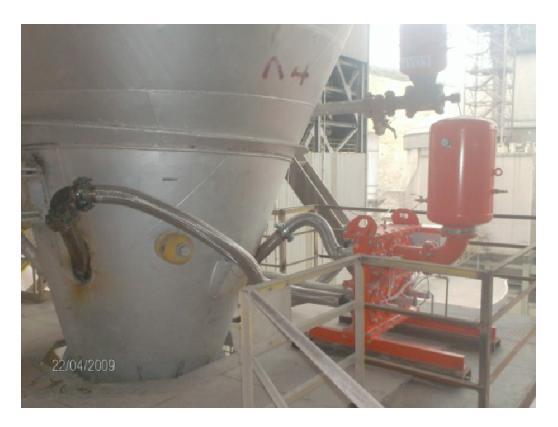
Meal Pipe Cyclone Discharge.

Nuh Cement Plant is one of Europe's largest cement plants with three clinker production lines and a capacity of 4,100,100 tons per year. The plant was battling buildup problems in the third line's cyclone discharge pipe following meal pipe expulsion. The buildup of sticky material created blockages leading to a smaller output opening at the bottom of the cyclone discharge pipe, causing serious production loss. To combat the blockage issues, the plant resorted to replacing the spare cyclone discharge, which required a 30-hour shutdown period (not including the cool down and heat up process). This forced stoppage had to be done every 5-6 months - when the cyclone disharge was no longer in operating condition - causing extra labor costs and time losses for the plant. With the third line's daily capacity reaching 7,200 tons, Nuh Cement Plant was losing a yearly production of 18,000 tons.

The Martin® Multi Port Air Cannon released air blasts on the bottom of the cyclone, breaking up and releasing material buildup and allowing for better material flow. The air cannons are performing with high-efficiency results and plant personnel have detected no blockage problems.
